NASA SP-238

APOLLO 11

Mission Report

PREPARED BY
MISSION EVALUATION TEAM
NASA MANNED SPACECRAFT CENTER

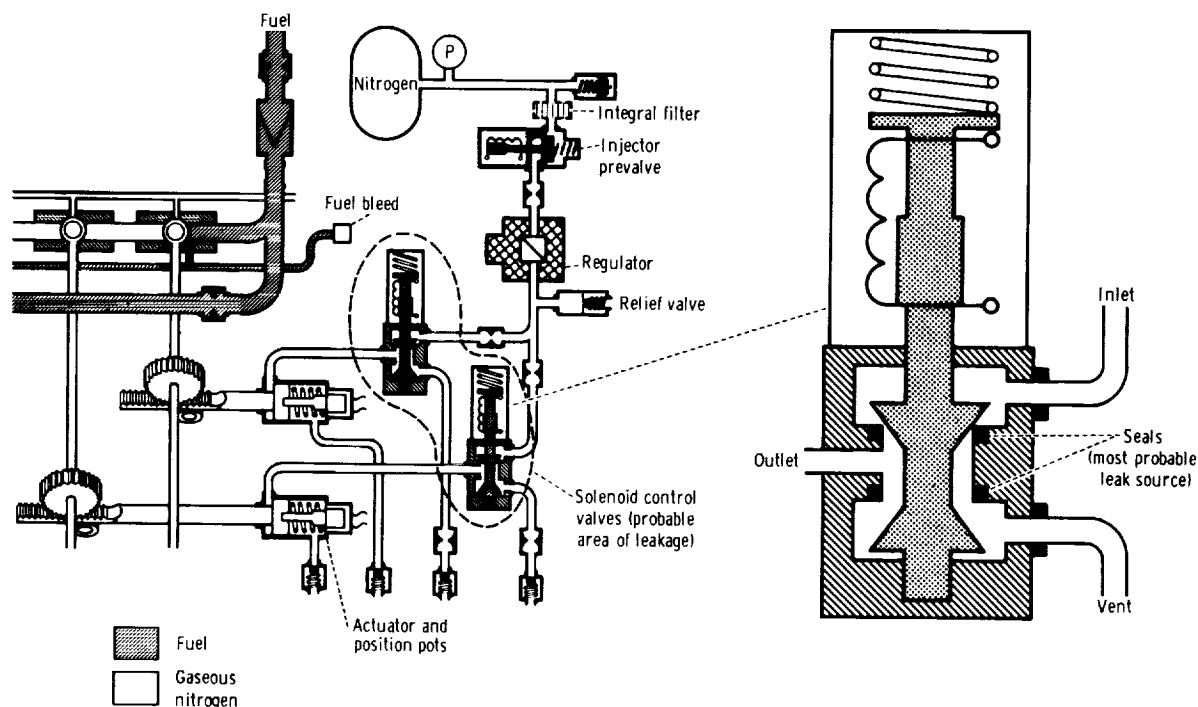
Figure 16-2.- Control for service propulsion propellants.

The fuel and oxidizer valves are controlled by actuators driven by nitrogen pressure. Figure 16-2 is representative of both nitrogen control systems. When power is applied to the service propulsion system in preparation for a maneuver, the injector prevalue is opened; however, pressure is not applied to the actuators, because the solenoid control valves are closed. When the engine is commanded on, the solenoid control valves are opened, pressure is applied to the actuator, and the rack on the actuator shaft drives a pinion gear to open the fuel and oxidizer valves. When the engine is commanded off, the solenoid control valve vents the actuator and closes the fuel and oxidizer valves.

The most probable cause of the problem was contamination of one of the components downstream of the injector pre valve, which isolates the nitrogen supply during nonfiring periods. The injector pre valve was not considered a problem source because it was opened 2 minutes before ignition, and no leakage occurred during that period. The possibility that the regulator and relief valve were leaking was also eliminated because pressure was applied to these components when the pre valve was opened.

It is concluded that the leakage was due to a contamination-induced failure of a solenoid control valve. The source of contamination is unknown; however, the contamination was apparently removed from the sealing surface during the valve closure for the first lunar orbit insertion maneuver (fig. 16-2). The suspected source is a contaminated facility manifold at the vendor's plant. Although an investigation of the prior failure indicated that the flight valve was not contaminated, the facility manifold is still considered a possible source of the contaminants.

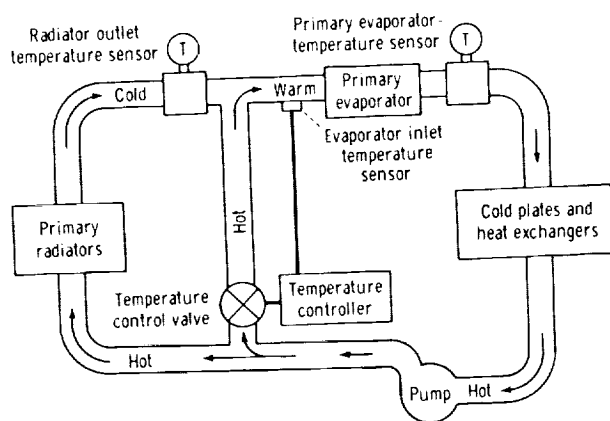
Figure 16-7.- Primary water/glycol coolant loop.

Glycol temperature control valve.- During lunar orbit operations, the glycol temperature control valve did not control the evaporator inlet temperature. The temperature of the water/glycol entering the evaporator is normally maintained above 42° F by the glycol temperature control valve, which mixes hot water/glycol with water/glycol returning from the radiators (fig. 16-7). As the radiator outlet temperature decreases, the temperature control valve opens to allow more hot glycol to mix with the cold fluid returning from the radiator. This procedure is followed to maintain the evaporator inlet temperature at 42° to 48° F. The control valve starts to close as the radiator outlet temperature increases and closes completely at evaporator inlet temperatures above 48° F. If the automatic temperature control system fails, manual operation of the temperature control valve is available by deactivating the automatic mode. This deactivation is accomplished by positioning the glycol evaporator temperature inlet switch from AUTO to MANUAL, which removes power from the control circuit.

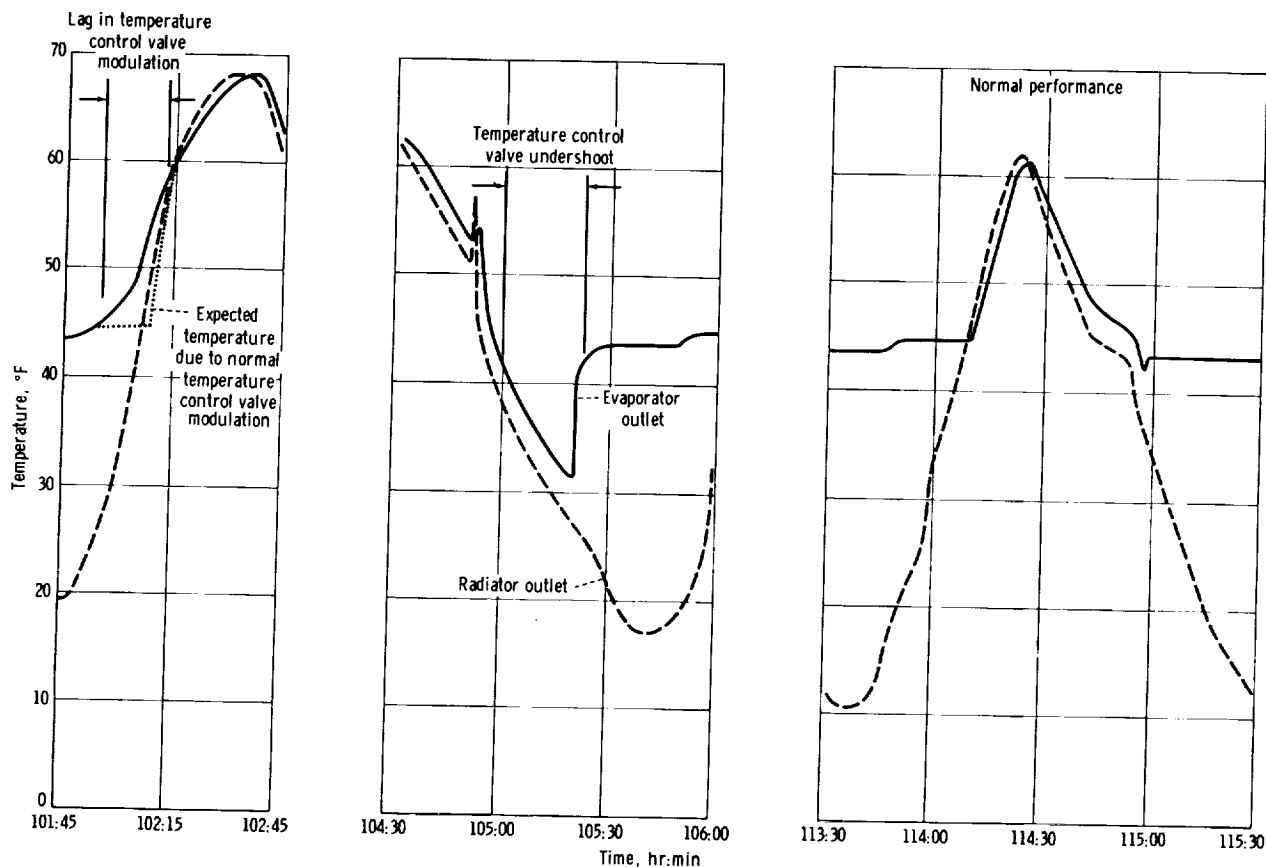
Figure 16-8.- Comparison of radiator and evaporator outlet temperatures.

Two problems occurred on Apollo 11 during lunar orbit operations. First, as the temperature of the water/glycol returning from the radiators increased, the temperature control valve did not close fast enough; thus, an early rise was produced in evaporator outlet temperature. Second, the evaporator outlet temperature decreased to 31° F during revolution 15 as the radiator outlet temperature was rapidly decreasing (fig. 16-8). Figure 16-8 also shows normal operation of the valve and control system after the problem. Both anomalies disappeared at approximately the time during revolution 15 that the glycol evaporator temperature inlet switch was cycled by the crew. The temperature control valve and related control system continued to operate satisfactorily for the remainder of the mission.

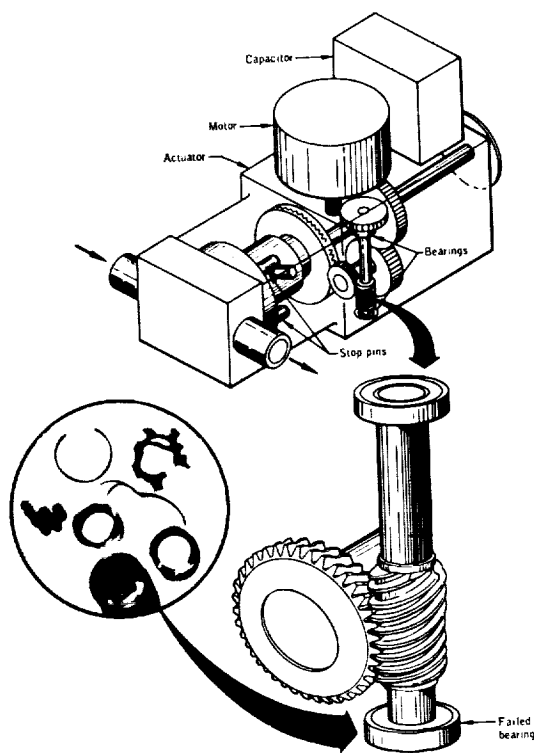
Figure 16-9.- Temperature control valve.

The control valve was removed from the spacecraft, disassembled, and inspected. A bearing within the valve gear train was found to have its retainer disengaged from the race so that the retainer interfered with the worm gear travel (fig. 16-9).

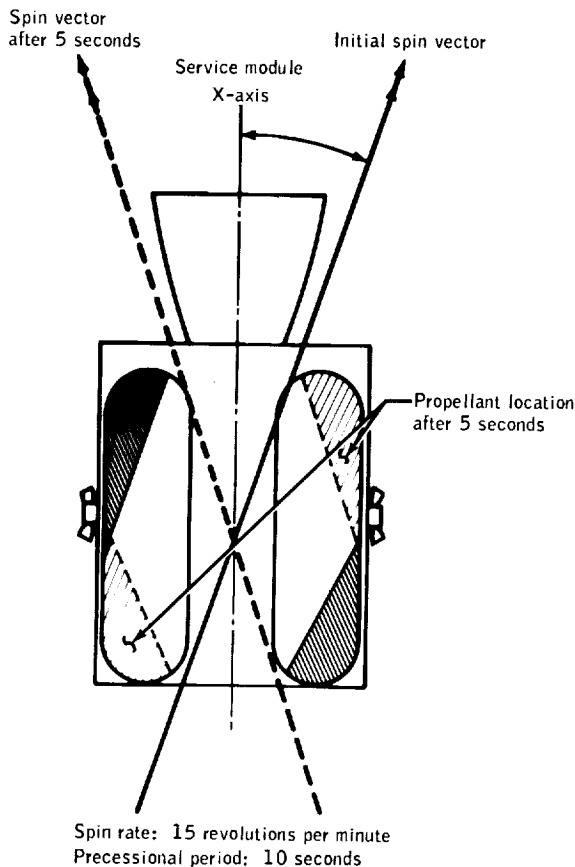
Figure 16-10.- Propellant sloshing effects.

Analysis of propellant sloshing shows, however, that the service module can become unstable, which results in low net separation velocities. Pictorial representation of the sloshing is shown in figure 16-10. The analyses indicate that tip-off moments applied to the service module at jettison cause the spin vector to precess about the service module X-axis. The precession excites longitudinal sloshing of the propellants in the tanks. Initial propellant locations are shown in heavy shading in figure 16-10. When the spin vector precesses to the other side of the X-axis, the propellants are driven to the other ends of the tanks, as shown in light shading. The sloshing then causes the spin vector to approach a position normal to the service module X-axis. The sloshing effects can cause a reduction in separation velocity, and during the 300-second thrusting period, the service module attitude can be reversed 180°. This condition introduces a remote possibility of recontact between the service module and the command module.

Analysis showed that the optimum separation velocity for a range of propellant loads can be obtained by restricting the roll thrusting to a period of 2 seconds and the X-axis thrusting to a period of 25 seconds. Therefore, beginning with the Apollo 13 mission, the service module jettison controller was modified to give the following jettison sequence.

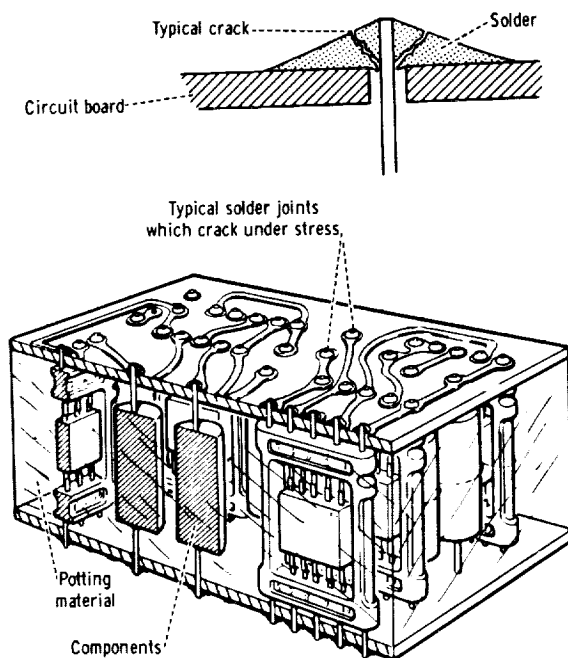
Figure 16-11.- Typical modular construction.

is, electrical components (resistors, capacitors, diodes, etc.) were soldered between two circuit boards, and the void between the boards was filled with potting compound (fig. 16-11). The differential expansion between the potting compound and the component leads caused the solder joints to crack and break electrical contact. Presumably, the 11-hour period the timer was off allowed the timer to cool sufficiently for the cracked joint to make electrical contact, and the timer then operated normally.

New mission timers and event timers that will be mechanically and electrically interchangeable with present timers are being developed. These new timers will use integrated circuits welded on printed circuit boards instead of the cordwood construction and will include design changes associated with the other timer problems such as cracked glass and electromagnetic interference susceptibility. The new timers will be incorporated into the spacecraft when qualification testing is complete.

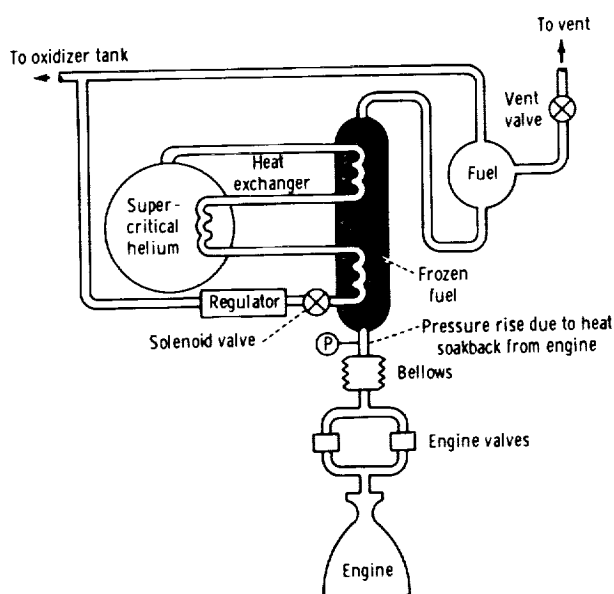
Figure 16-12.- Supercritical helium flow for descent propulsion system.

High fuel interface pressure after landing.- During simultaneous venting of the descent propellant and supercritical helium tanks, fuel in the fuel/helium heat exchanger was frozen by the helium flowing through the heat exchanger. Subsequent heat soakback from the descent engine caused expansion of the fuel trapped in the section of line between the heat exchanger and the engine shutoff valve (fig. 16-12). The result was a pressure rise in this section of line. The highest pressure in the line was probably in the range of 700 to 800 psia. (The interface pressure transducer range is 0 to 300 psia.) The weak point in the system is the bellows links, which yield at pressures greater than 650 psia and fail at approximately 800 to 900 psia. Failure of the links would allow the bellows to expand and relieve the pressure without external leakage. The heat exchanger, which is located in the engine compartment, thawed within approximately 0.5 hour and allowed the line pressure to decay.

On future missions, the solenoid valve (fig. 16-12) will be closed prior to fuel venting and opened some time prior to lift-off. This procedure will prevent freezing of fuel in the heat exchanger and will allow the supercritical helium tank to vent later. The helium pressure rise rate after landing is approximately 3 to 4 psi/hr and constitutes no constraint to presently planned missions. Appropriate changes will be made to operational procedures.

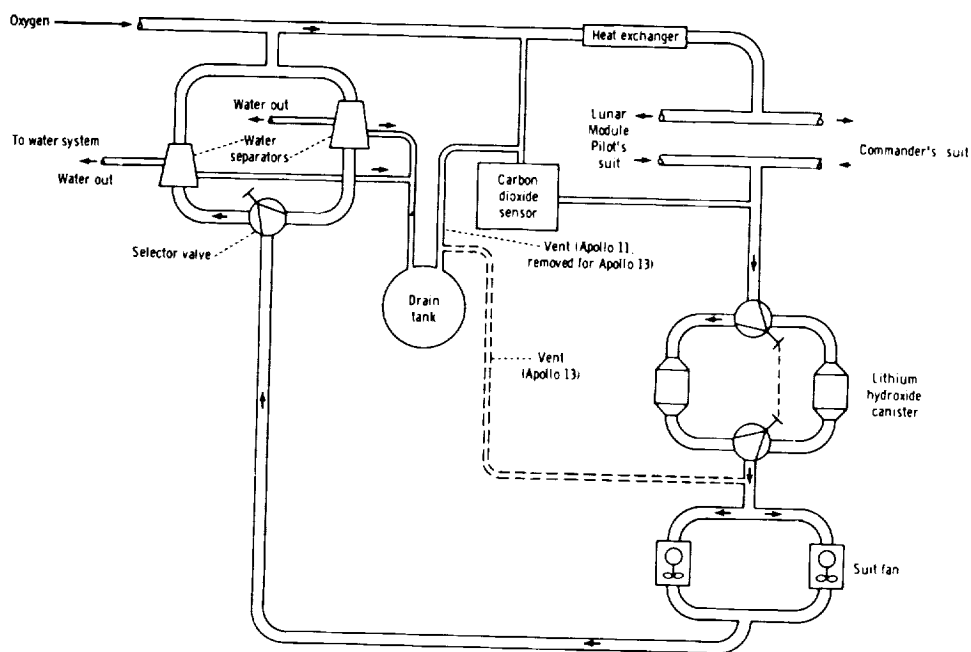
Figure 16-13.- Simplified suit-loop schematic.

into a tank (fig. 16-13). The drain tank contained a honeycomb material designed to retain the condensate. If the amount of condensate exceeded the effective surface of the honeycomb, water could have leaked through the vent line and into the system just up stream of the sensor. (Before the sensor became erratic, the Commander had noted water

The possible sources of free water in the suit loop are the water separator drain tank, an inoperative water separator, local condensation in the suit loop, and leakage through the water separator selector valve (fig. 16-13). An evaluation of each of these possible sources indicated that leakage through the water separator selector valve was the most probable source of the free water.

in his suit.) Free water in the optical section of the sensor will cause erratic performance. The carbon dioxide content is sensed by measuring the light transmission across a stream of suit-loop gas. Any liquid in the element affects the light transmission and thus gives improper readings. To preclude water being introduced into the sensor from the drain tank, the vent line was relocated to an existing boss upstream of the fans, effective on Apollo 13 (fig. 16-13).

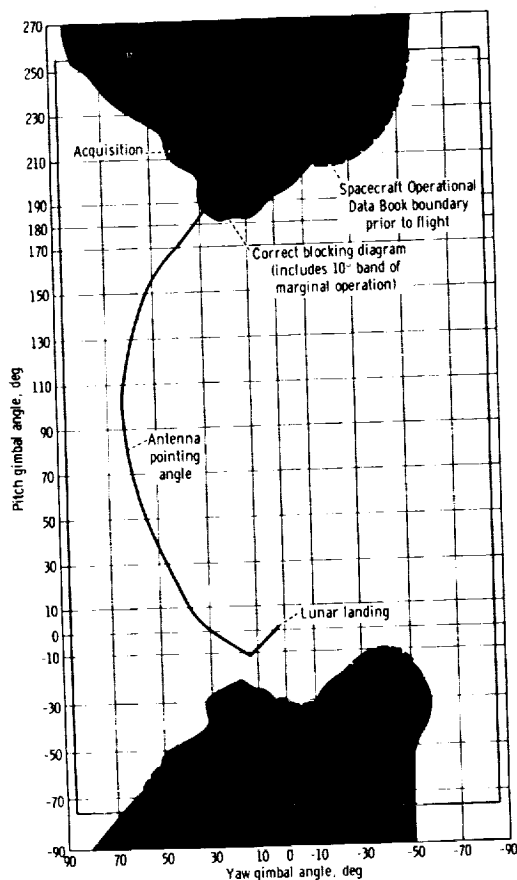
Figure 16-14.- Coverage restrictions for S-band steerable antenna.

For the pointing angles used, errors were discovered in the antenna coverage restriction diagram in the Spacecraft Operational Data Book. In addition, the diagram failed to include the thruster plume deflectors, which were added to the lunar module at the launch site. Figure 16-14 shows the correct blockage diagram and the diagram that was used in the Spacecraft Operational Data Book prior to flight. The pointing angles of the antenna were in an area of blockage or sufficiently close to blockage to affect the coverage pattern. As the antenna boresight approaches the vehicle structure, the on-boresight gain is reduced, the selectivity to incoming signals is reduced, and sidelobe interference is increased. Furthermore, a preflight analysis showed that the multipath signal, or reflected ray (fig. 16-15), from the lunar surface to the vehicle flight trajectory would be sufficient to cause some of the antenna tracking losses. Also, the reduction in antenna selectivity caused by vehicle blockage increases the probability of multipath interferences in the antenna tracking circuits. In conclusion, both the vehicle blockage and the multipath signals probably contributed to the reduced measured signal.

For future missions, the correct vehicle blockage and multipath conditions will be determined for the predicted flight trajectory. Operational measures can be employed to reduce the probability of the recurrence of this problem by selecting vehicle attitudes that orient the antenna away from vehicle blockages and by selecting vehicle attitude hold with the antenna track mode switch in the SLEW or MANUAL position throughout the time periods when this problem may occur.

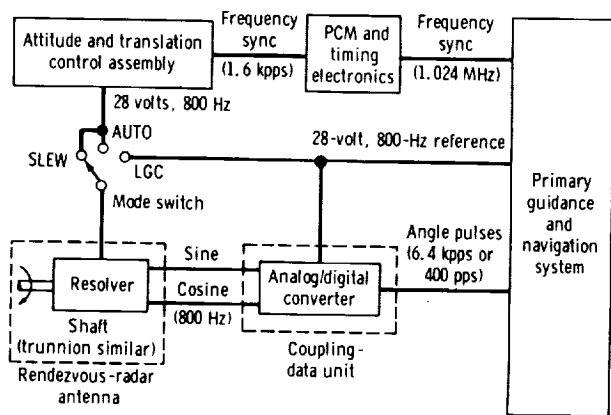
Figure 16-16.- Interfaces from rendezvous-radar antenna to primary guidance system.

The alarms were of the Executive overflow type, which signify that the guidance computer cannot accomplish all of the data processing requested in a computation cycle. The alarms indicated that more than 10 percent of the computation capacity of the computer was preempted by unexpected counter interrupts of the type generated by the coupling data units which interface with the rendezvous-radar shaft and trunnion resolvers (fig. 16-16).

The interrupts during the powered descent resulted from the configuration of the rendezvous-radar/coupling data unit/computer interface. A schematic of the interface is shown in figure 16-16. When the rendezvous-radar mode switch is in the AUTO or SLEW position, the excitation for the radar shaft and trunnion resolvers is supplied by a 28-volt, 800-hertz signal from the attitude and translation control assembly. When the switch is in the LGC position, the positioning of the radar antenna is controlled by the guidance computer, and the resolver excitation is supplied by a 28-volt, 800-hertz source in the primary guidance and navigation control system. The output signals of the shaft and trunnion resolvers interface with the coupling data units, regardless of the excitation source. The attitude and translation control assembly voltage is locked in frequency with the primary guidance and navigation control system voltage through control (by the primary guidance and navigation control system) of the PCM and timing electronics frequency, but it is not locked in phase. When a mode switch is not in LGC, the attitude and translation control assembly voltage is the source for the resolver output signals to the coupling data units, while the primary guidance and navigation control system 800-hertz voltage is used as a reference voltage in the analog-to-digital conversion portion of the coupling data unit. Any difference in phase or amplitude between the two 800-hertz voltages will cause the coupling data unit to recognize a change in shaft or trunnion position, and the coupling data unit will "slew" (digitally). The "slewing"

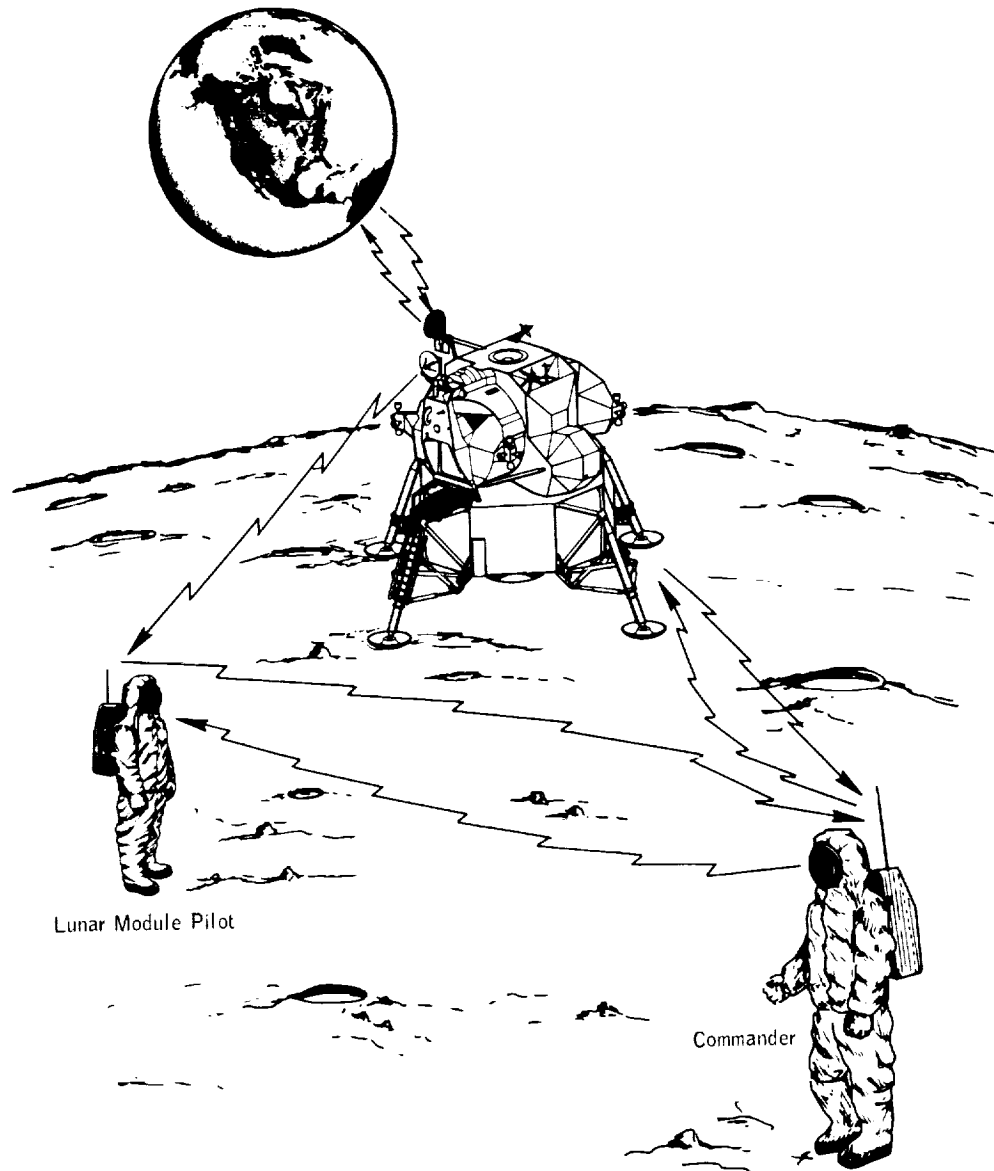
Figure 16-18.- Communications relays during extravehicular activity.

Echo during extravehicular activity.— A voice turnaround (echo) was heard during extravehicular activity. At that time, the lunar module was operating in a relay mode. Up-link voice from the S-band was processed and retransmitted to the two extravehicular crewmen by means of the lunar module vhf transmitter. Crew voice and data were received by the lunar module vhf receiver and relayed to the earth by means of the lunar module S-band transmitter (fig. 16-18). The echo, which was duplicated in the laboratory, resulted from mechanical acoustical coupling between the communications carrier earphone

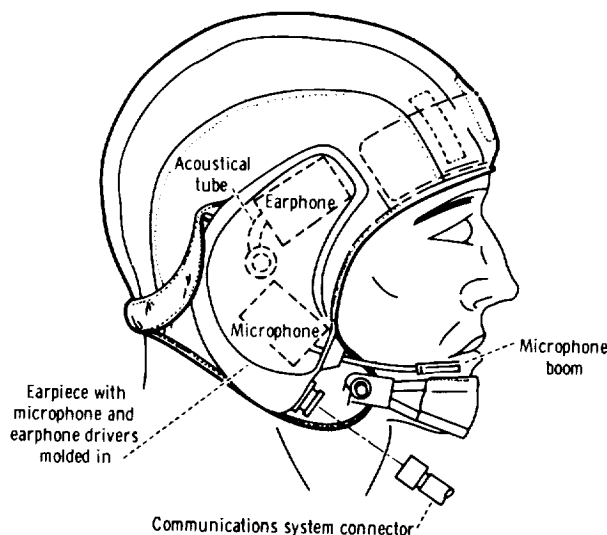
Figure 16-19.- Communications carrier.

and microphone (fig. 16-19). The crewmen indicated that their volume controls were set at maximum during the extravehicular activity. This setting would provide a level of approximately +16 dBm into each crewman's earphones. Isolation between earphones and microphones, exclusive of airpath coupling, is approximately 48 decibels. Therefore, at the microphone output, the ground voice signal would appear at a level of approximately -32 dBm. If it is assumed that extravehicular communications keying was enabled, this signal would be processed and transmitted by the extravehicular communications system and would provide a level of approximately -12 dBm at the output of the lunar module vhf receiver. If the lunar module relay was enabled, this signal would be amplified and relayed to earth by means of the S-band at a nominal output level.

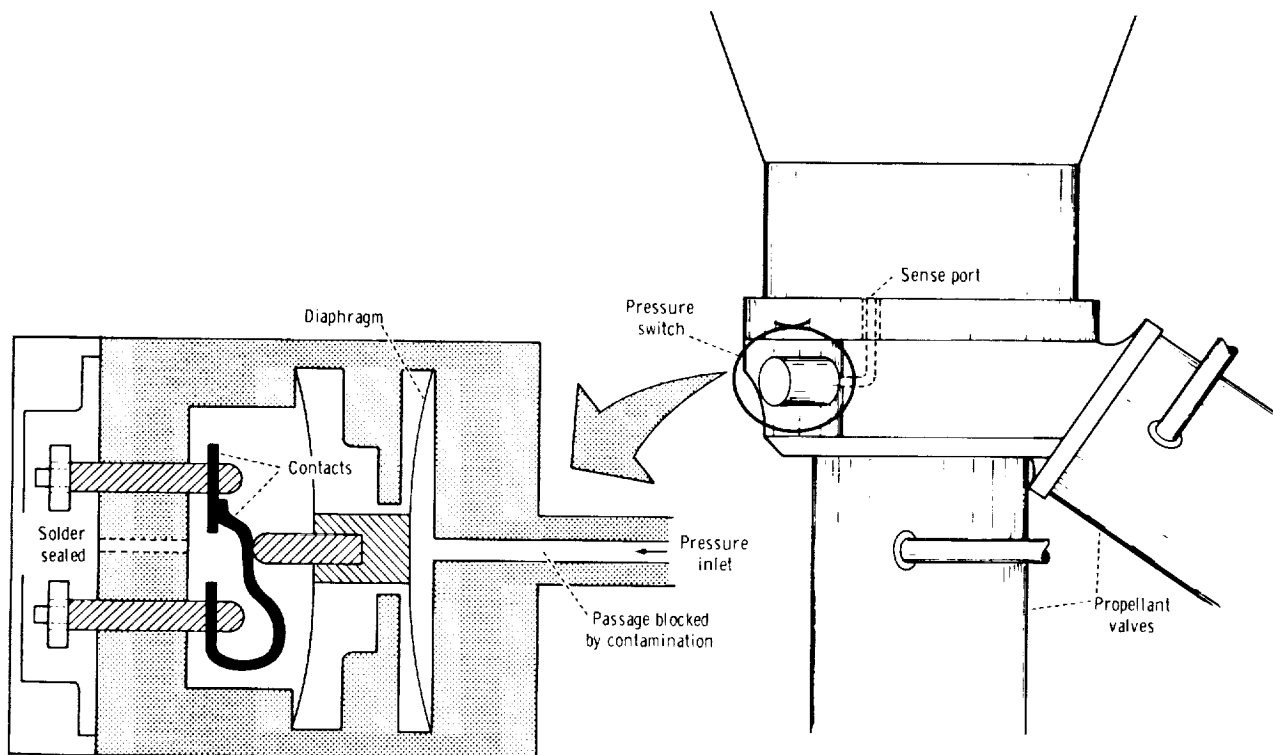
Figure 16-20.- Chamber pressure switch.

Thrust chamber pressure switches.- The switch used to monitor the quad 2 aft-firing engine (A2A) exhibited slow response to jet driver commands during most of the mission. During an 18-minute period just prior to terminal phase initiation, the switch failed to respond to seven consecutive minimum-impulse commands. This failure resulted in a master alarm and a thruster warning flag, both of which were reset by the crew. The engine operated normally, and the switch failure had no effect on the mission. The crew did not attempt any investigative procedures to determine whether the engine had actually failed. A section drawing of the switch is shown in figure 16-20.

This failure was the first of its type to be observed in flight or in ground testing. The switch closing response (time of jet driver ON command to switch closure) appeared to increase from an average of approximately 15 to 20 milliseconds during station keeping to 25 to 30 milliseconds at the time of failure. Normal switch closing response is 10 to 12 milliseconds, based on ground test results. The closing response remained at the 25- to 30-millisecond level following the failure, and the switch continued to fail to respond to some minimum-impulse commands. The switch opening time (time from jet driver OFF command to switch opening) appeared to be normal throughout the mission. In view of these results, the most probable cause of the switch failure was particulate contamination in the inlet passage of the switch. Contamination in this area would reduce the flow rate of chamber gases into the diaphragm cavity, thereby reducing the switch closing response. However, the contamination would not necessarily affect switch opening response because normal chamber pressure tailoff requires approximately 30 to 40 milliseconds in order to decrease from approximately 30 psia to the normal switch opening pressure of approximately 4 psia. The 30- to 40-millisecond time would probably be sufficient to allow the gases in the diaphragm cavity to vent such that the switch would open normally. The crews for future missions will be briefed to recognize and handle similar situations.

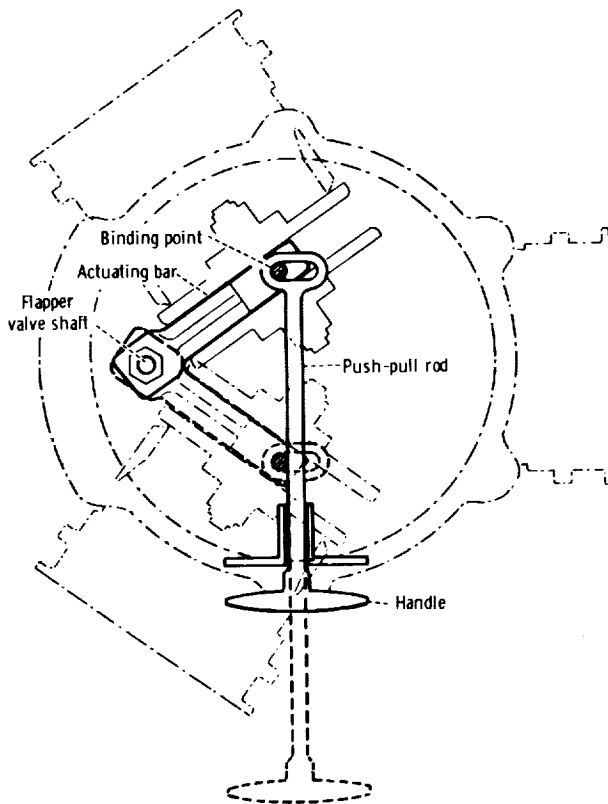
Figure 16-21.- Water separator selector valve.

The flapper-type valve is located in a Y-duct arrangement and is used to select one of two water separators. Leakage of this valve would allow free water to pass through the idle water separator and subsequently enter the suit hose. This leakage would most probably result from a misalignment and binding in the slot of the selector valve actuation linkage (fig. 16-21).

The allowable actuation force after linkage rigging was 15 pounds. The usual actuation forces have been 7 to 8 pounds, but 12.5 pounds were required on the Apollo 11 mission. The allowable actuation force has been lowered to 10 pounds, and inspections for linkage binding have been incorporated into procedures at the factory and the launch site.

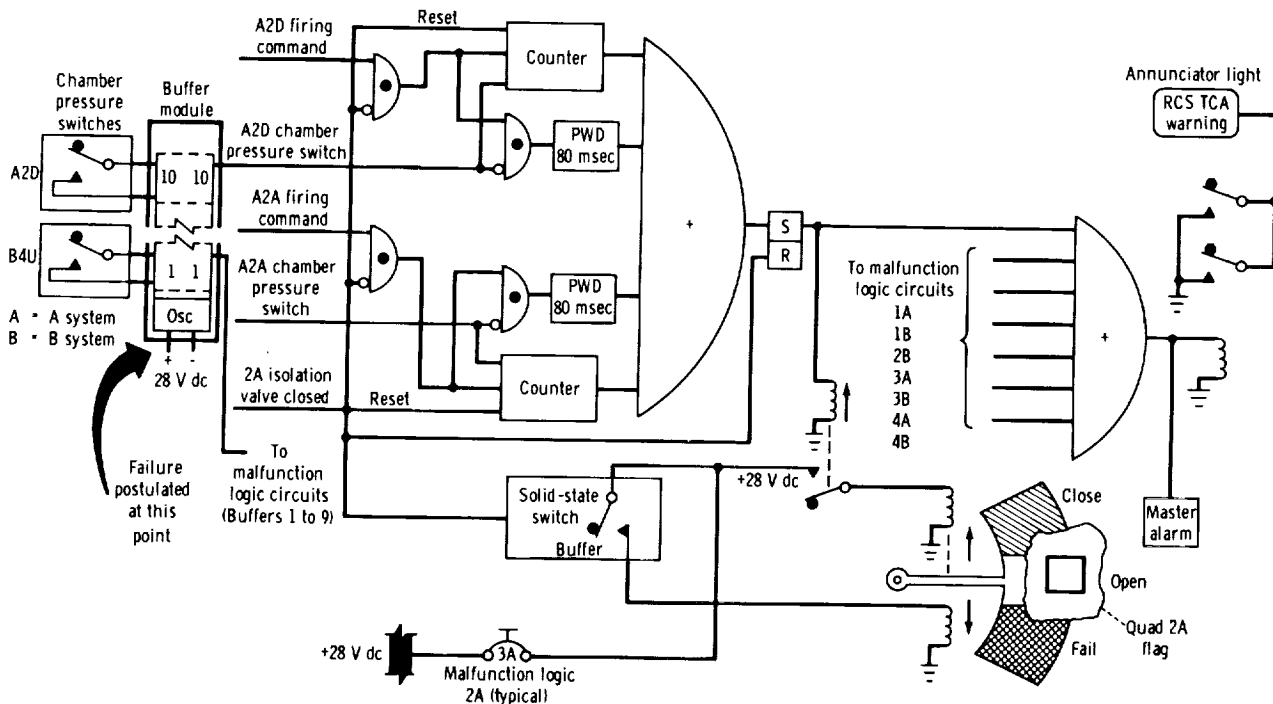
Figure 16-22.- Reaction control system malfunction-detection circuits.

The first two possible causes are unlikely because simultaneous multiple failures would have to occur and subsequently be corrected. The third possible cause is the most likely to have occurred where a single-point failure existed. Ten of the 16 engine pressure switch outputs are conditioned by the 10 buffers in one module in the signal conditioner electronics assembly (fig. 16-22). This module is supplied with +28 V dc through one wire. In addition, the module contains an oscillator that provides an

ac voltage to each of the 10 buffers. If either the +28 V dc is interrupted or the oscillator fails, none of the 10 buffers will respond to pressure switch closures. If engines monitored by these buffers are then commanded on, the corresponding warning flags will appear, and a master alarm will occur.

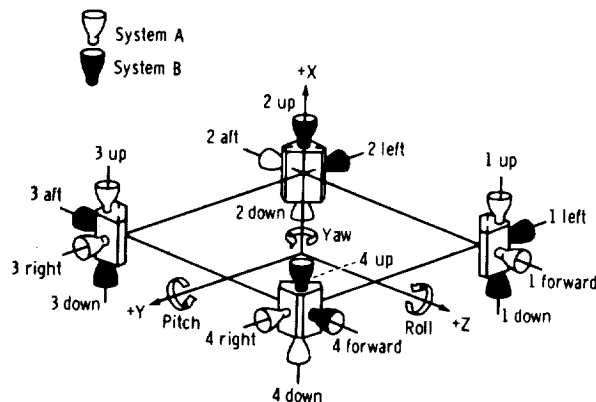
Figure 16-23.- Reaction control system geometry.

If plus X translation were commanded (fig. 16-23), the down-firing engines in quads 2 and 4 of system A could fire, and flags 2A and 4A would appear. A subsequent minus X rotation could fire the forward-firing thruster in quad 4 of system B and the aft-firing thruster in quad 2 of system A, and flag 4B would appear. The aft-firing engine in quad 2 of system A (A2A) is not monitored by one of the 10 buffers postulated as having failed. The failure, then, could have cleared itself. The response of the vehicle to thruster firings would have been normal under these conditions. There is no history of similar failures either at package or module level in the signal conditioner electronics assembly. No corrective action was taken.

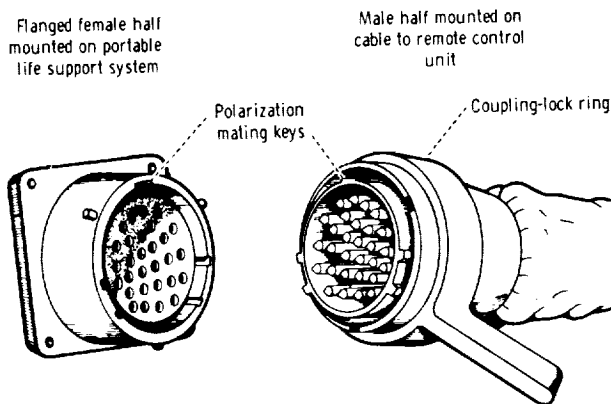
Figure 16-24.- Connector between remote control unit and portable life support system.

Mating of remote control unit to portable life support system.- During preparation for extravehicular activity, the crew experienced considerable difficulty in mating the electrical connectors from the remote control unit to the portable life support system. For rotational polarization alignment, it was necessary to grasp the cable insulation because the coupling lock ring was free for unlimited rotation on the connector shell (fig. 16-24).

For future missions, the male half of the connector has been replaced with one that has a coupling lock ring with a positive rotational position with the connector shell and that can be grasped for firm alignment of the two halves. The ring is then rotated 90° in order to capture and lock the two halves. In addition, easier insertion has been attained with conical-tipped contact pins in place of hemispherical-tipped pins.
